Heritage Repairs using the  
Cold Metallock Process

ID7466 Earn Viaduct Perth

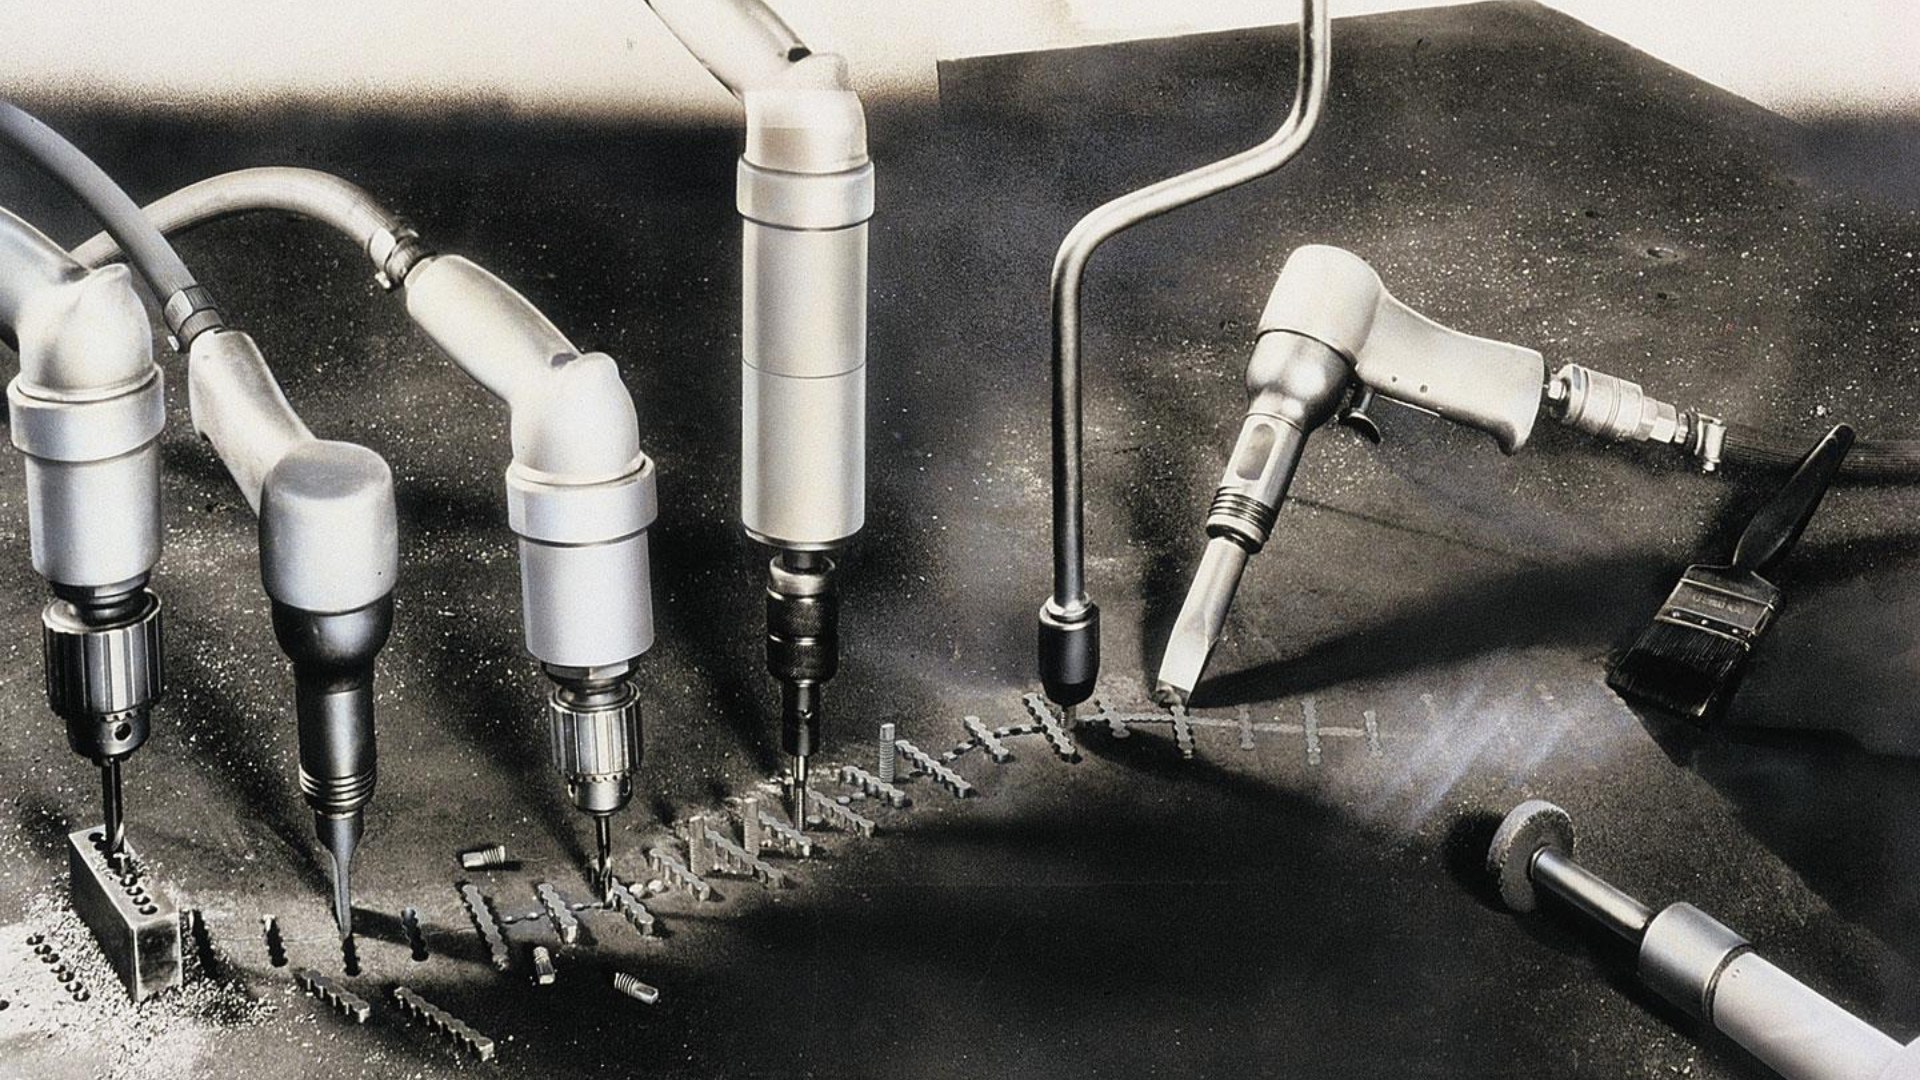
## Metallock Casting Repair Process

1. Using a drill jig, rows of blind holes are drilled perpendicular to the direction of the crack, each row to act as a key.
2. The intermediate partitions are removed with pneumatic chisel.
3. Metallock keys are driven into the opening and caulked.
4. Holes for Metallock screws are drilled along the crack between the keys.
5. The screws are fitted to ensure they overlap, effecting a seal along the fracture.
6. Finally, the entire installation is caulked to ensure stability and pressure tightness.

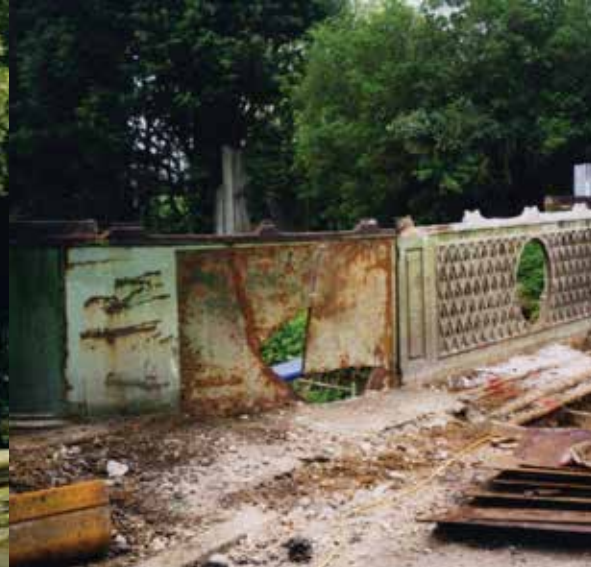
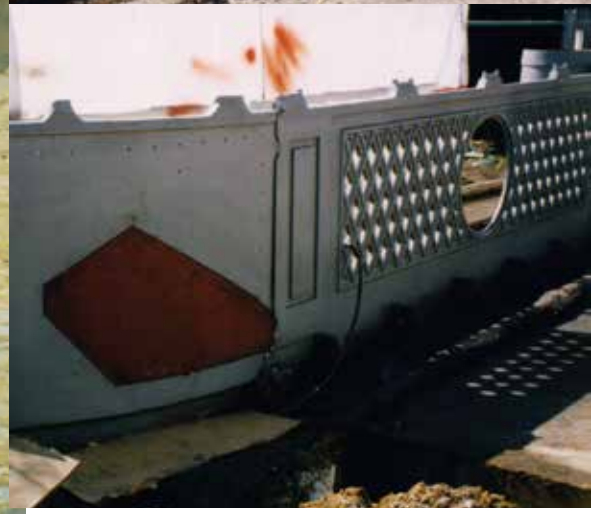
Metal stitching repairs on cast iron canal bridge.

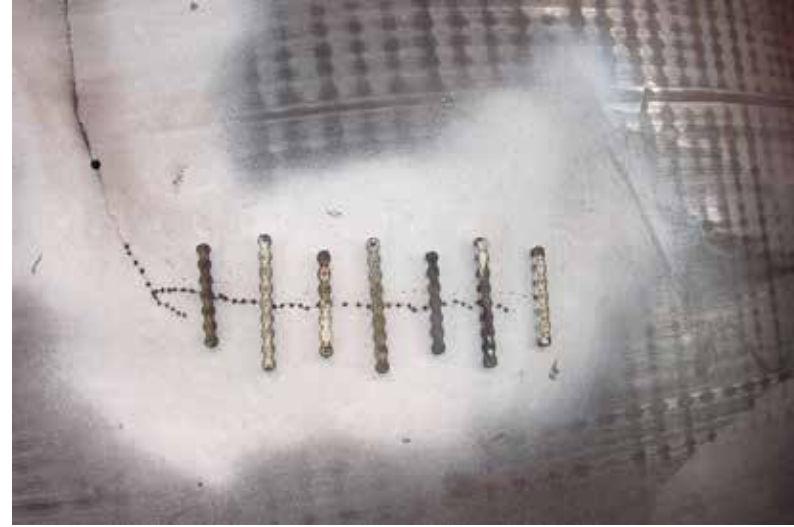
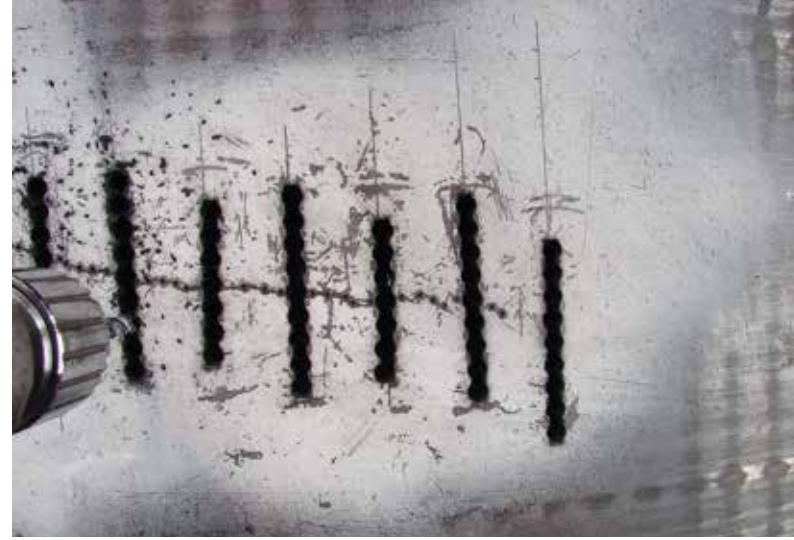
# Metal Stitching Repair Process

The Metalock repair consists of peening into prepared apertures layers of multi-dumbbell shaped keys. These keys are manufactured from a special highly ductile alloy (MN211) specifically developed by Metalock's own engineers and unobtainable outside the Metalock organisation.

The illustration of the Metallock repair system, is a basic repair to a flat surface. Damage to more complex fractures and castings requires the Metallock Engineer to draw on his skills and knowledge in coping with both the difficulties of the component's shape, its operation and its environment.

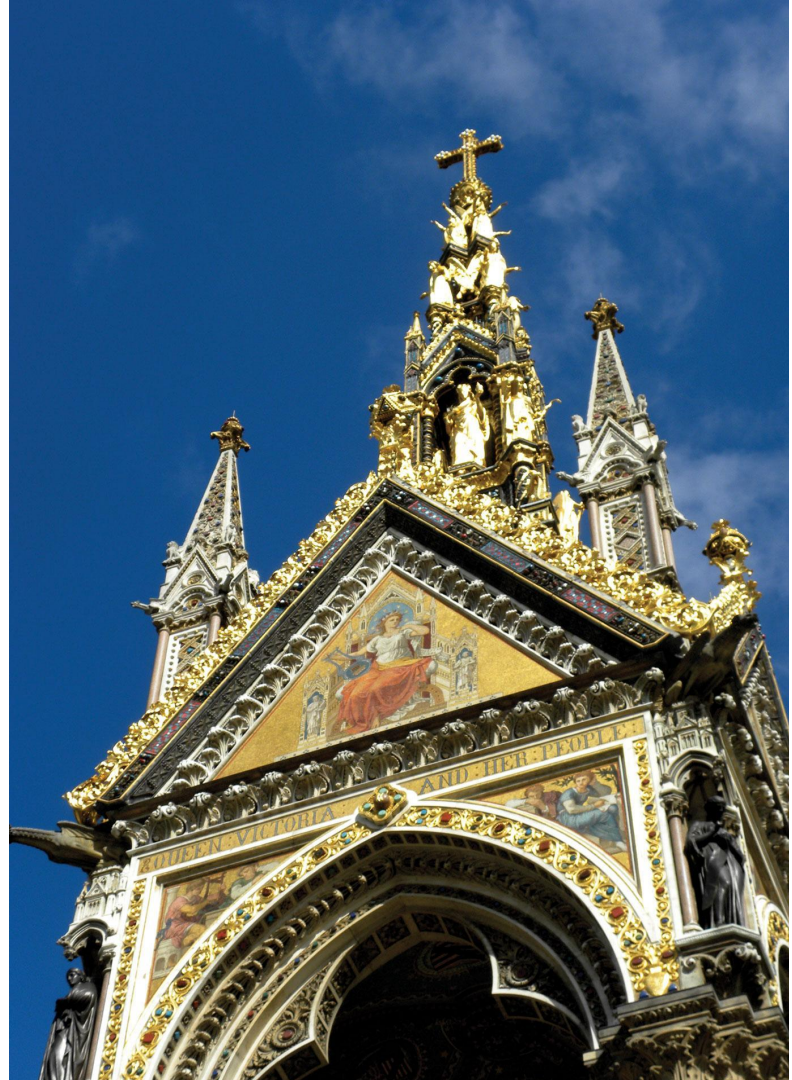
Pictures shows stitching new to old on one of the upper gables in Metallock's workshop.

Metalock Engineering UK Ltd were asked by English Heritage to repair the 135-year old Albert Memorial, which stands opposite The Albert Hall in London. Upon completion of a thorough inspection it was decided to retain as much of the original castings as possible with Metalock cutting away major damage and supplying new sections, these were then secured into position using the Metalock cold repair process.

Following casting repairs, all components were cleaned and red lead painted before the lead claddings were put back with improved slip joints enabling expansion and contraction without causing splits.

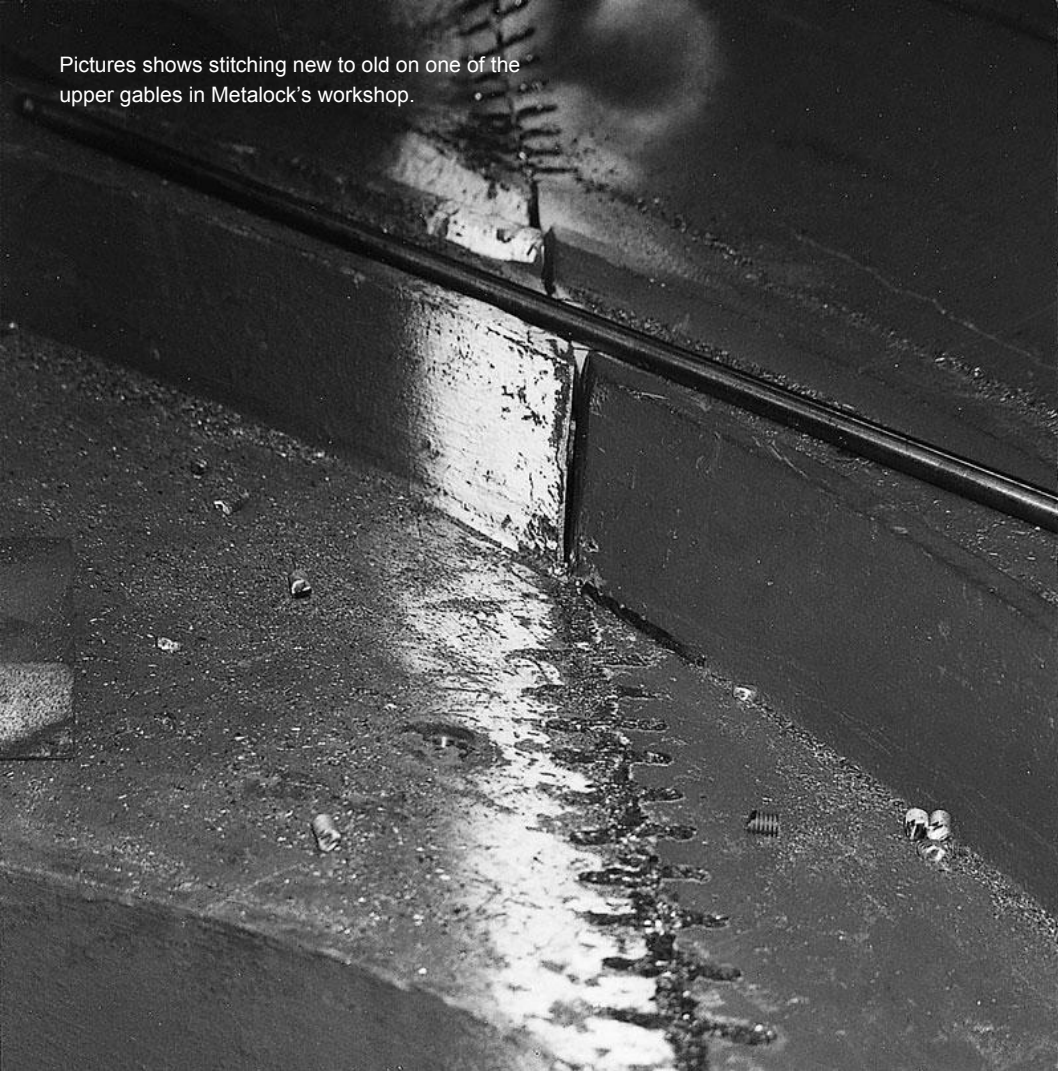
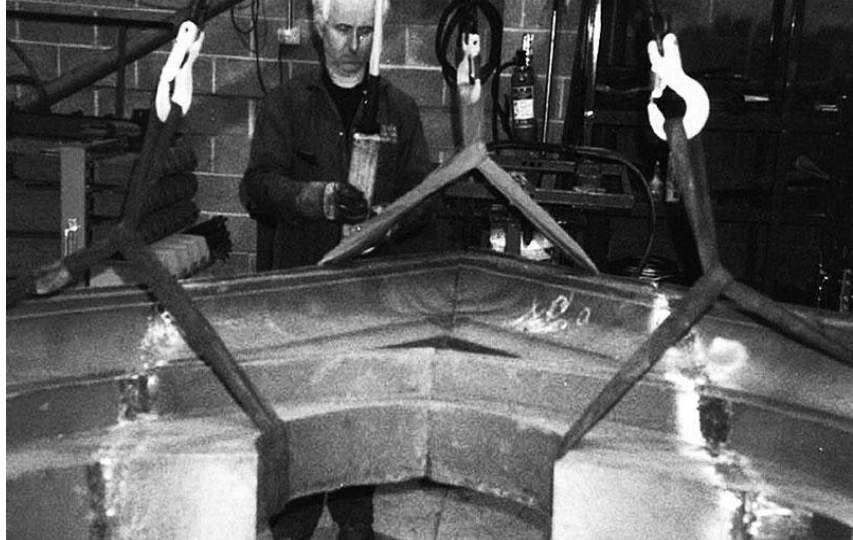
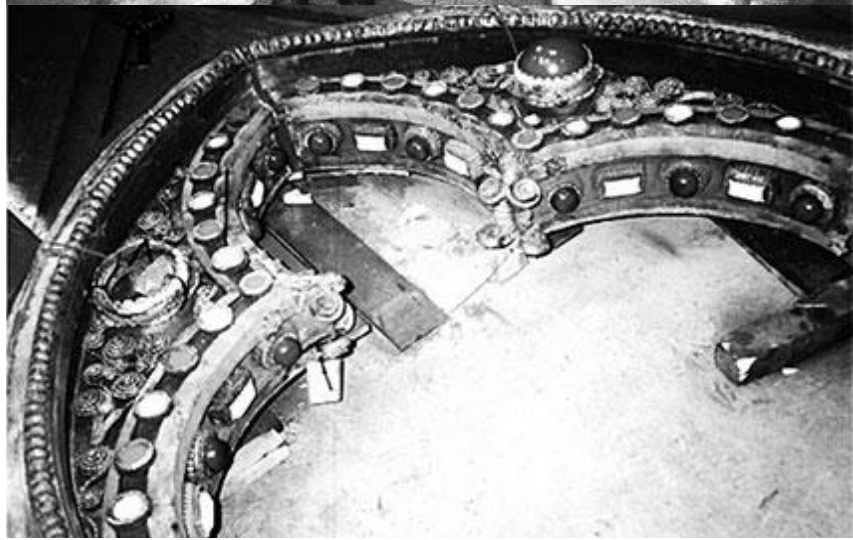
The memorial is constructed from elaborate cast iron sections, up to 75mm thick, clad in lead and decorated with bronze and mosaics. There is also wrought iron, early mild steel, copper and gold. The lead in places is 20mm thick.

In the original design there was no provision for the lead to expand, and being constrained it buckled in hot weather. Eventually, the buckled areas cracked and split and let water into the cast iron core leading to corrosion over the years. Corrosion jacked up the lead even more which increased the cracking. Parts of the cast iron core were severely corroded and in some areas there were cracks. These might have been the result of settlement over the years.

***Nearly 100 metres of “Metalocking” was used to repair broken and badly cracked core castings comprising the elements London’s Albert Memorial.***

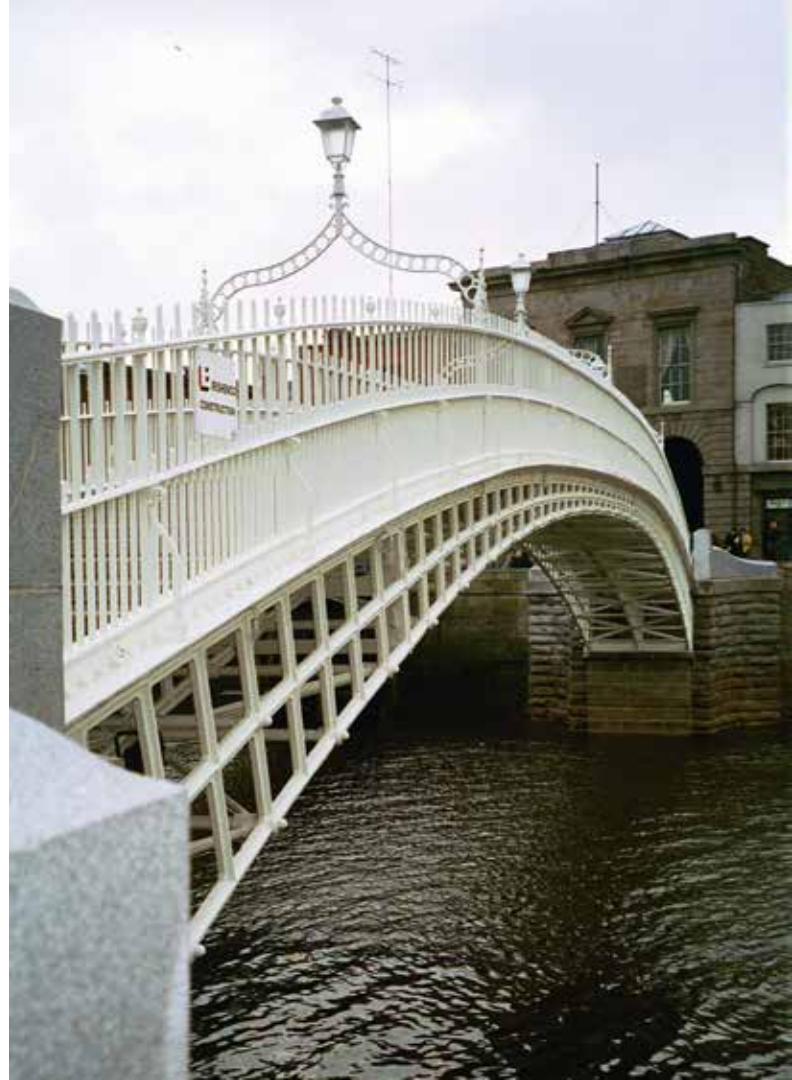
The bridge is a List 1 structure in the Dublin Corporation Development plan and takes its name from the Ha'Penny toll collected between its construction in 1816 to the toll ending in 1915. Although it's present official name is the Liffey Bridge, it was originally the Wellington Bridge and comprises an assembly of elliptical arch ribs. These were most probably cast in the Coalbrookdale Works in Shropshire from a design attributed to Thomas Telford.

Most of the damage to the components that needed repair had been caused by expansion due to corrosion from moisture ingress following the breakdown of joint sealing materials.

Metalock carried out a series of magnetic particle inspection checks on various critical components and, using its Metalock metal stitching techniques repaired the damaged parts.

Ha'penny bridge was closed for the restoration and a one-piece Bailey bridge located alongside for pedestrian crossing. The deck was removed and new sections fabricated to match the bridge's distorted elliptical shape. New ductile iron ornamental railing sections have also been cast. The project included repainting in its original off-white colour. Most of Metalock's work involved tie-rod end caps, 43 of which had cracks and were repaired, and cracked diaphragm rib plates. Additionally, Metalocking was used to repair construction webs and install new corbel sections to replace those that had broken off over the years.

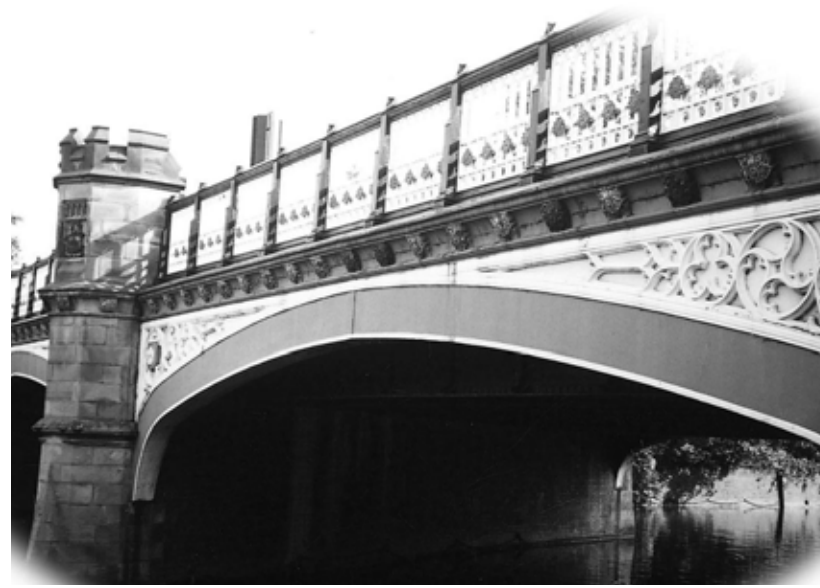
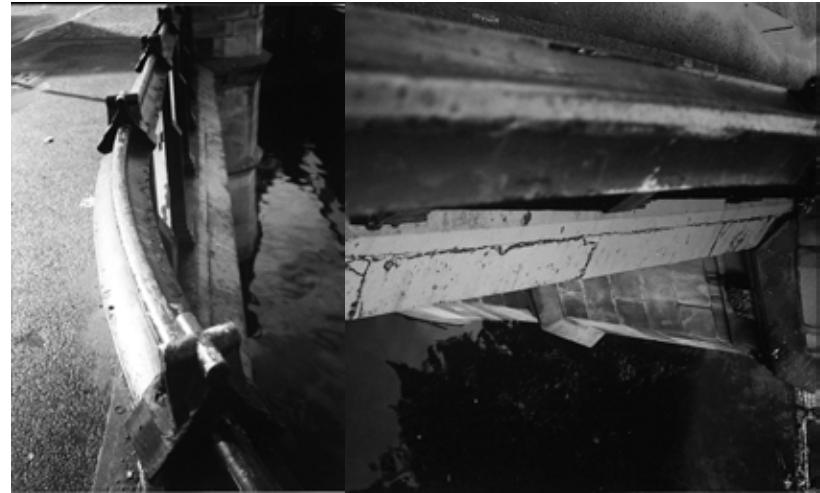
# Old West Bridge

Metalock Engineering UK has used its cold repair expertise to repair and refurbish parapet panels, copings and cornices on the Old West Bridge in Leicester.

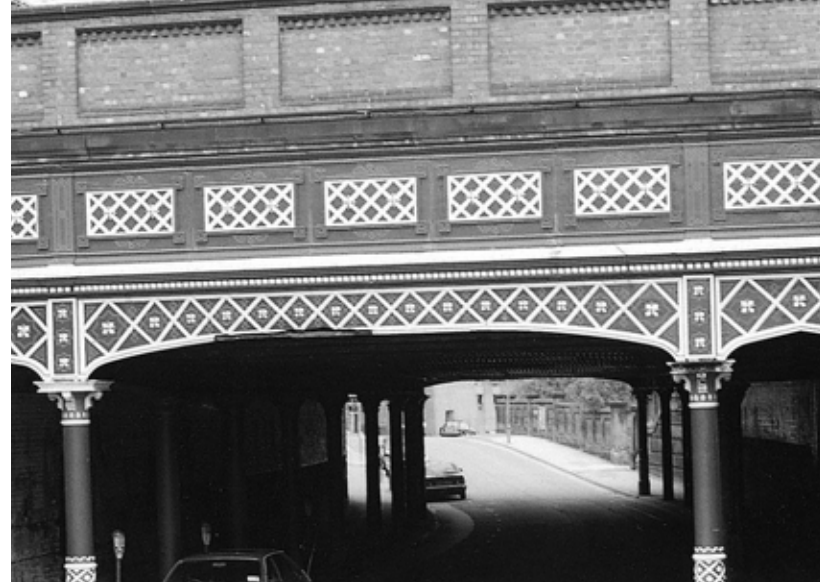
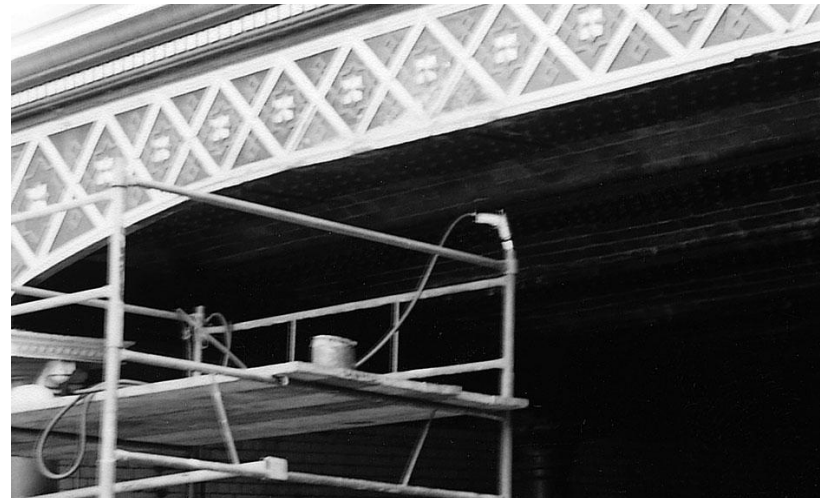
## Gas Street Bridge

The scourge of low cast iron bridges are high sided vehicles coming into contact with the structures, causing major damage. Metalock are able to replace these areas with new sections secured into position by the cold repair process, as was done at the Gas Street Bridge in Birmingham.

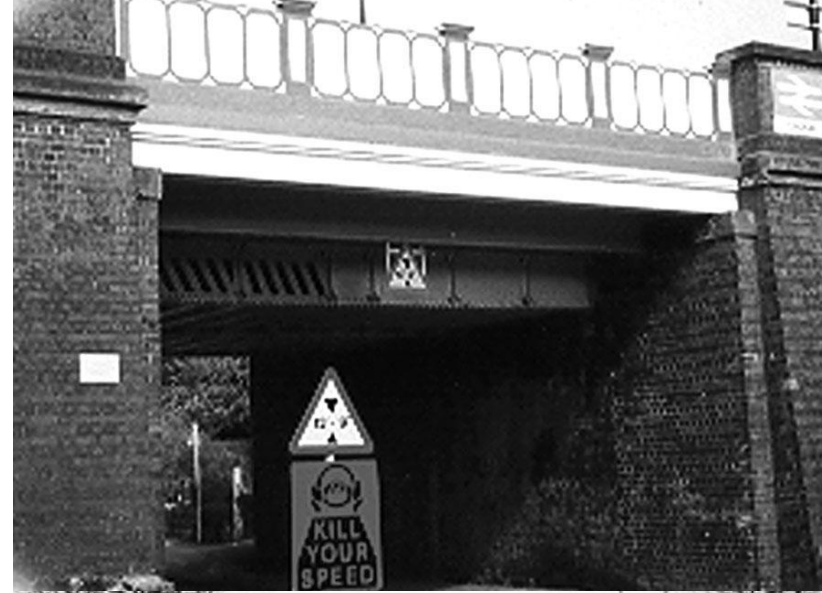
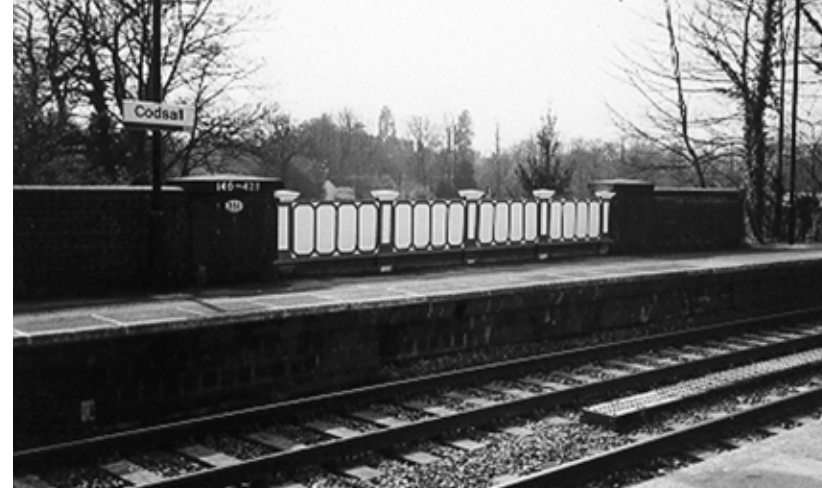
# Codsall Railway Bridge

Broken cast iron lips that hold parapet panels in place on a Grade II listed railway bridge at Codsall in South Staffordshire have been repaired by Metalock Engineering.

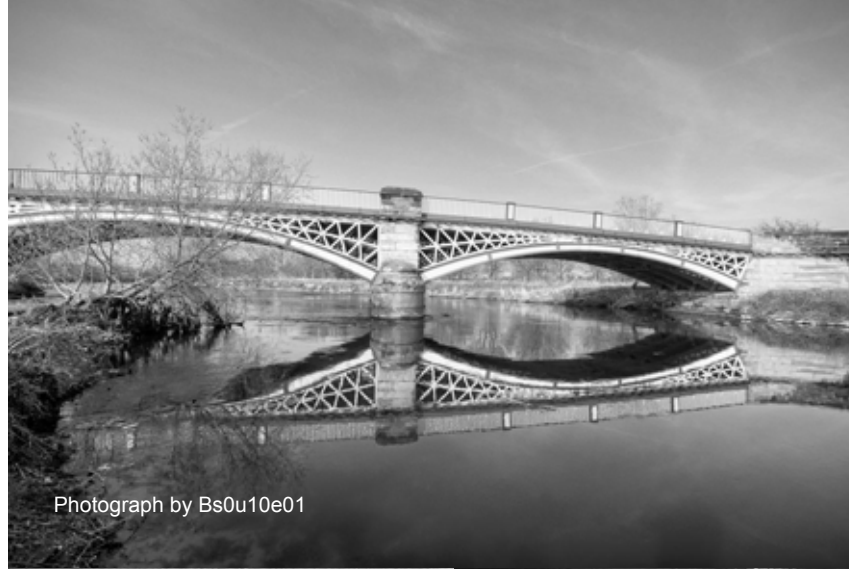
Photograph by Bs0u10e01

Chetwynd bridge in Staffordshire that had developed fractures, it was decided that the company's cold repair process could provide an effective and long lasting repair.

Seventy four metres of cracks were repaired without dismantling the bridge, taking three months to complete.

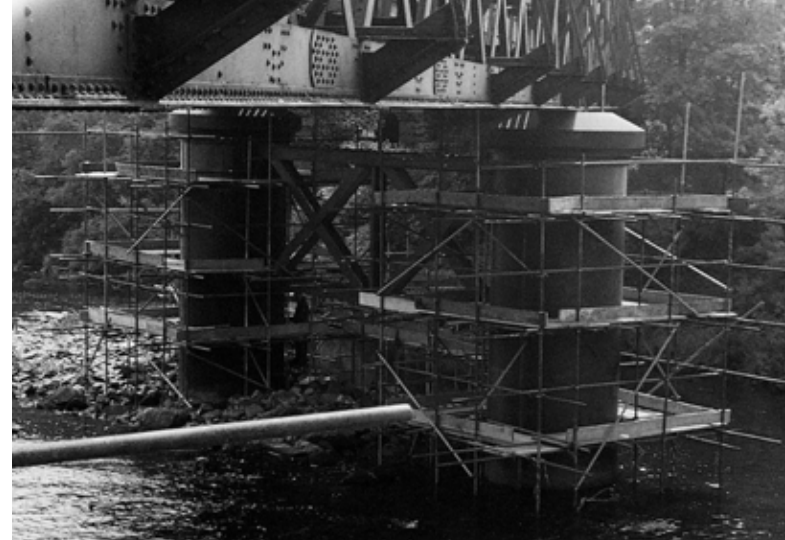
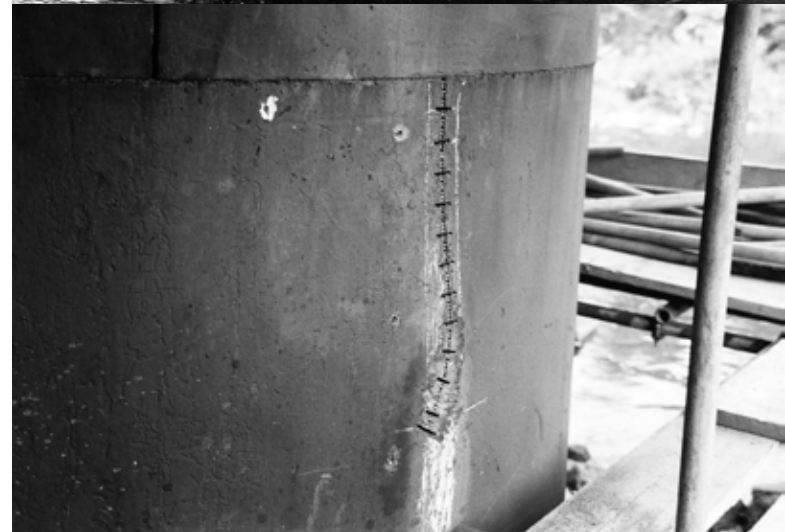
# Northumberland Bridge

Metalock Engineers undertaking repairs to cast iron Column supporting a river bridge in Northumberland.

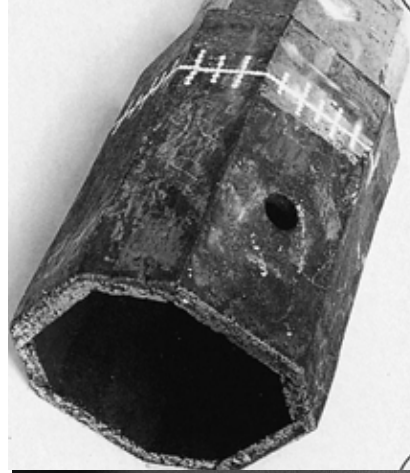
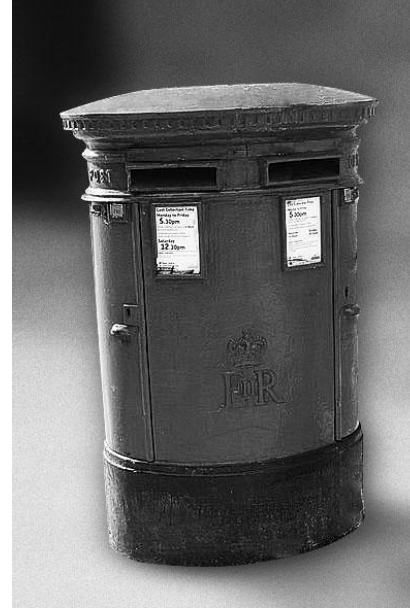
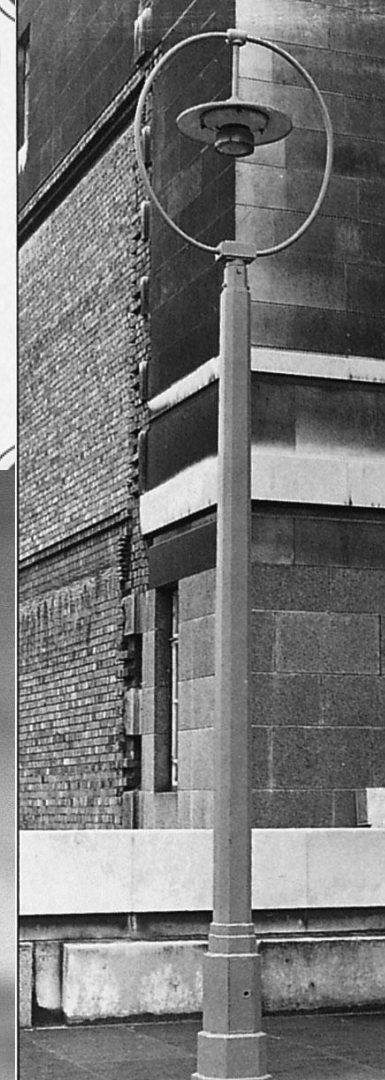
A 50 year old double ended oval main posting box in the commercial centre of Leeds.

The Post Office commissioned Metalock to carry out a speedy repair to a 63" fracture in the 11/4" thick casting.

A lamp post architect-designed to blend with the University of London's Senate House Complex, which was shattered after being struck by a lorry.

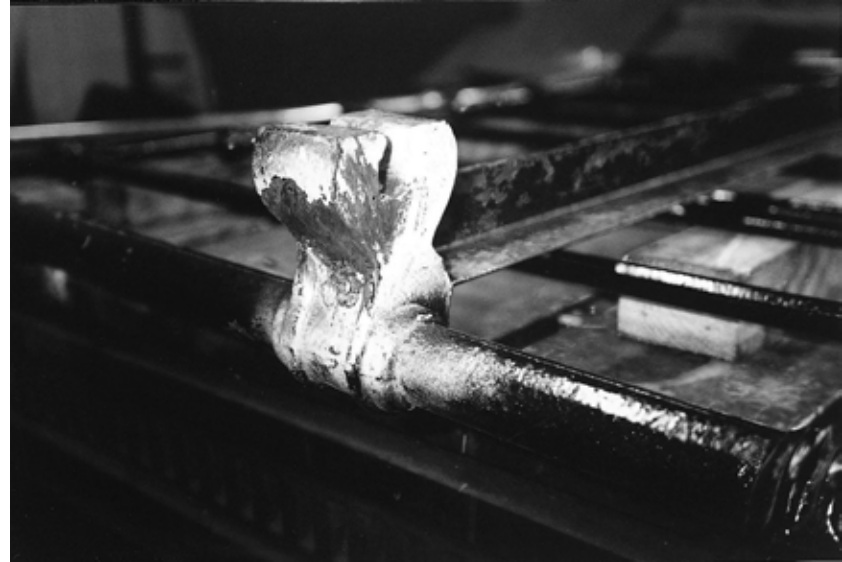
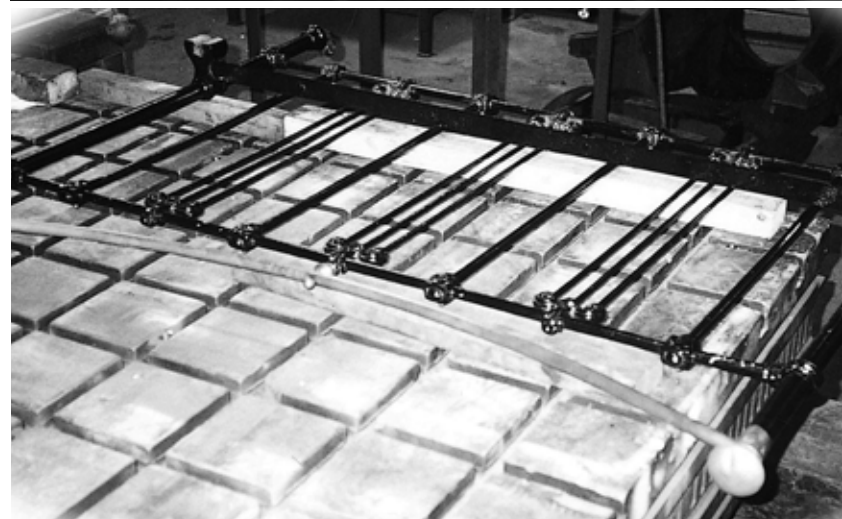
## Ornate Gate

Irreplaceable gates restored to pristine condition after a damaged lug was repaired using the Metalock repair process.

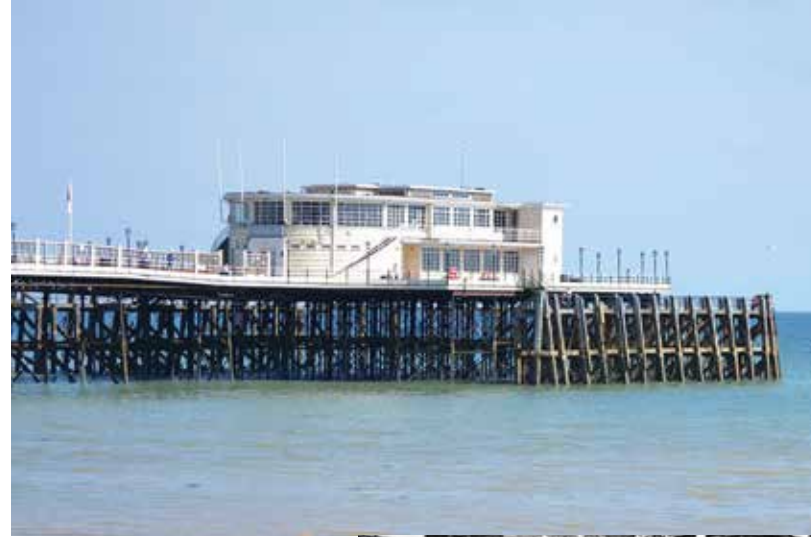
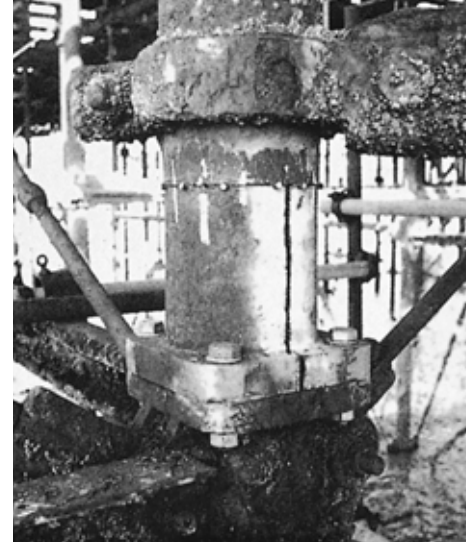
# Worthing Pier

Following a crack detection survey by Metalock to the cast iron columns of the pier, originally constructed in 1862, Worthing Borough Council commissioned the company to repair the columns under the Southern Pavilion which had been damaged by years of corrosion and erosion.

Conducted with the columns in position, this operation required only 82 man days to complete.

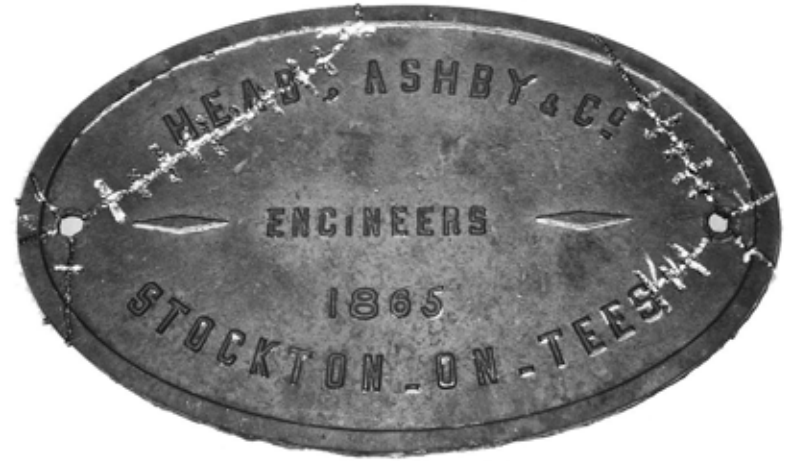
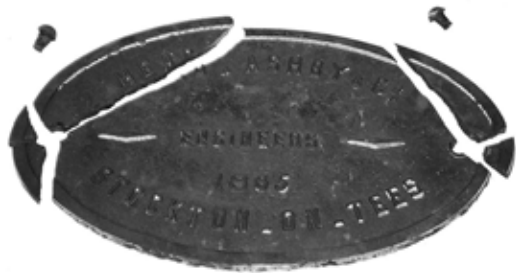
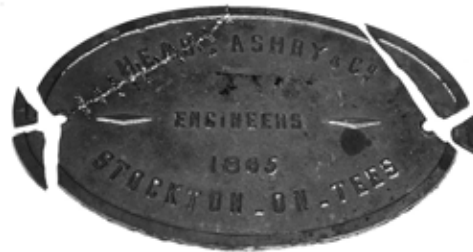
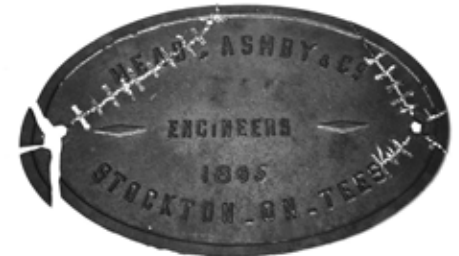
## Head Ashby & Co, Name plate

Historical Name Plate suffers damage and is repaired by the Metalock process thus retaining its originality.

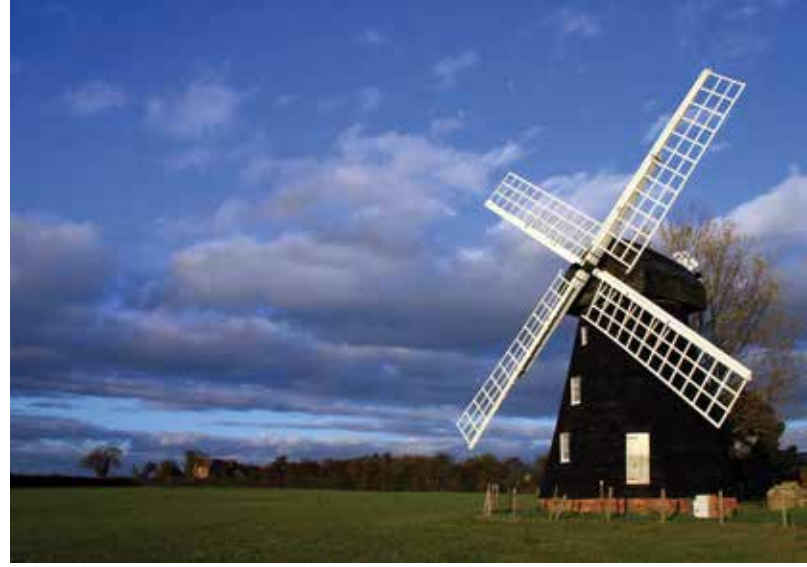
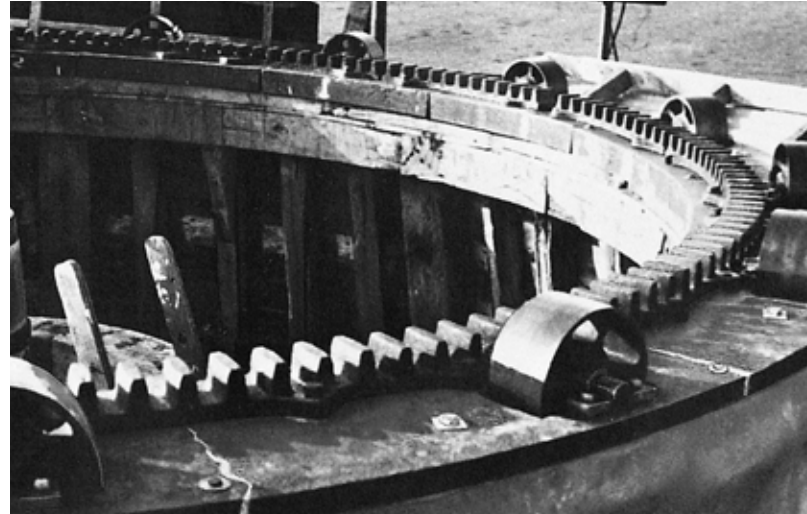
# Lacey Green Windmill

Metalock repaired ten segmental castings, six of which were cracked, and four broken in two. In addition, ten circular rack sections were broken in two or three pieces. From patterns Metalock were able to repair these and also produce three additional segmental sections.

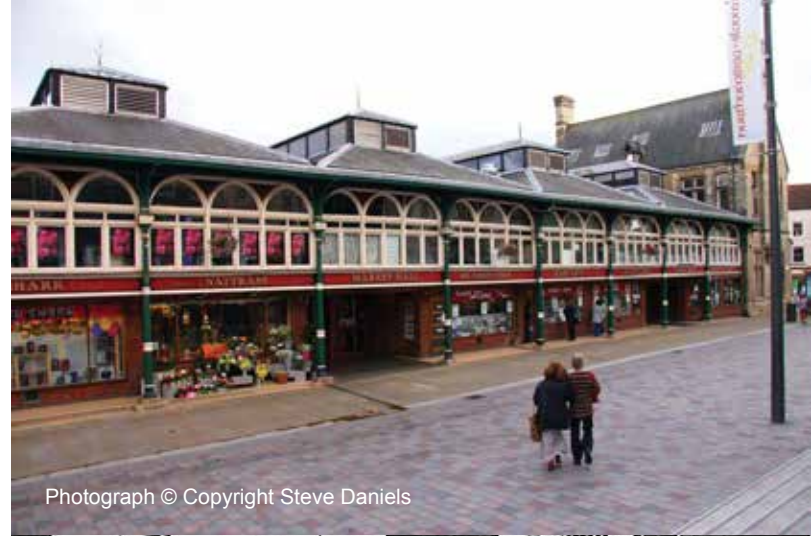
Photograph © Copyright Steve Daniels

Restoration of this 100 year old historic covered market was carried out under a preservation order. Inspection showed 24” to 48” fractures in six of the cast iron architectural columns supporting the roof. As it was virtually impossible to replace the columns without a total stripdown, a repair was essential, avoiding the shortcomings of welding.

The Metalock repair required no dismantling, was guaranteed and approved by Lloyd's.

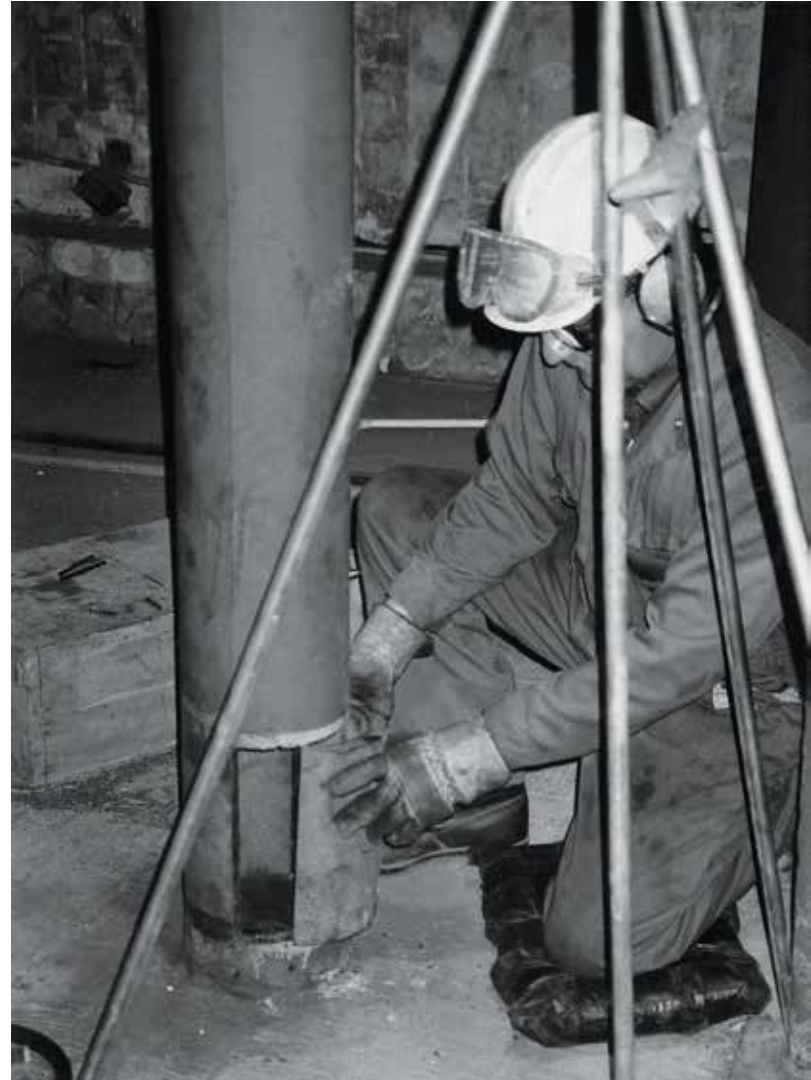
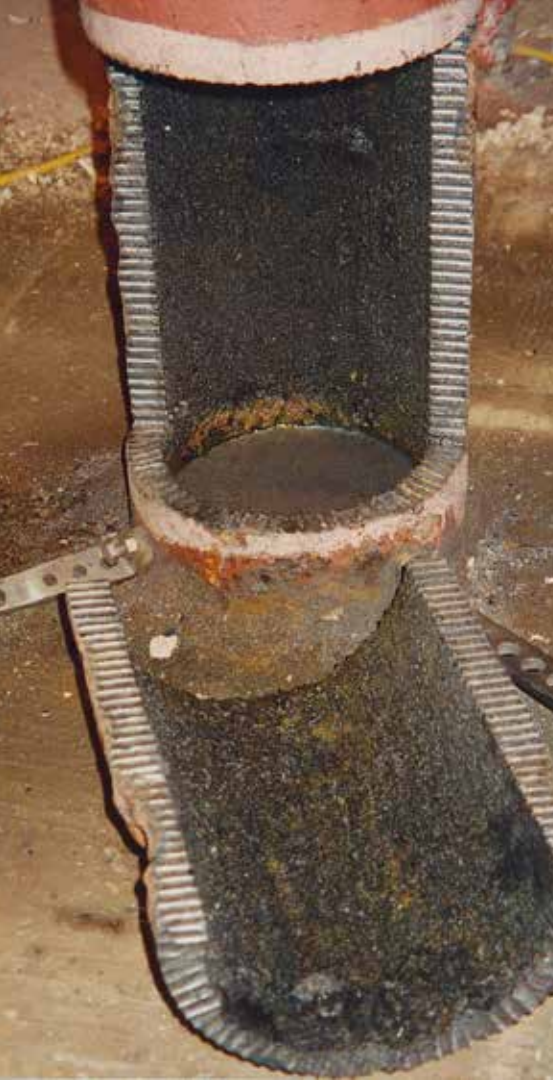
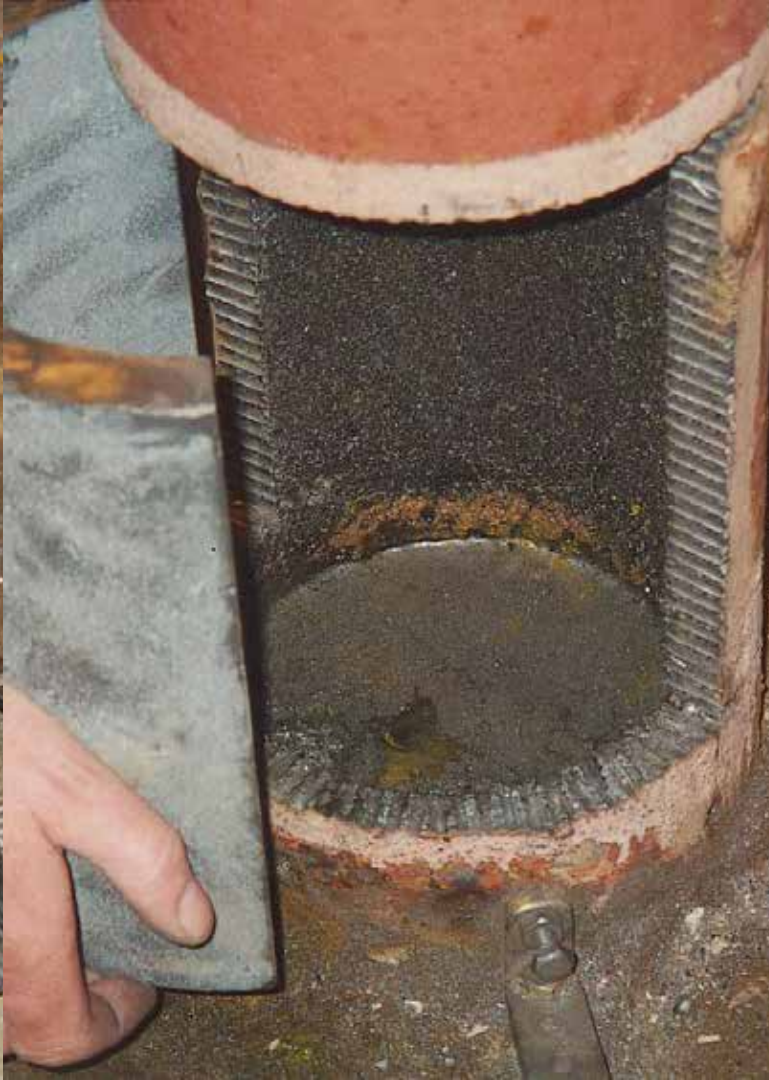
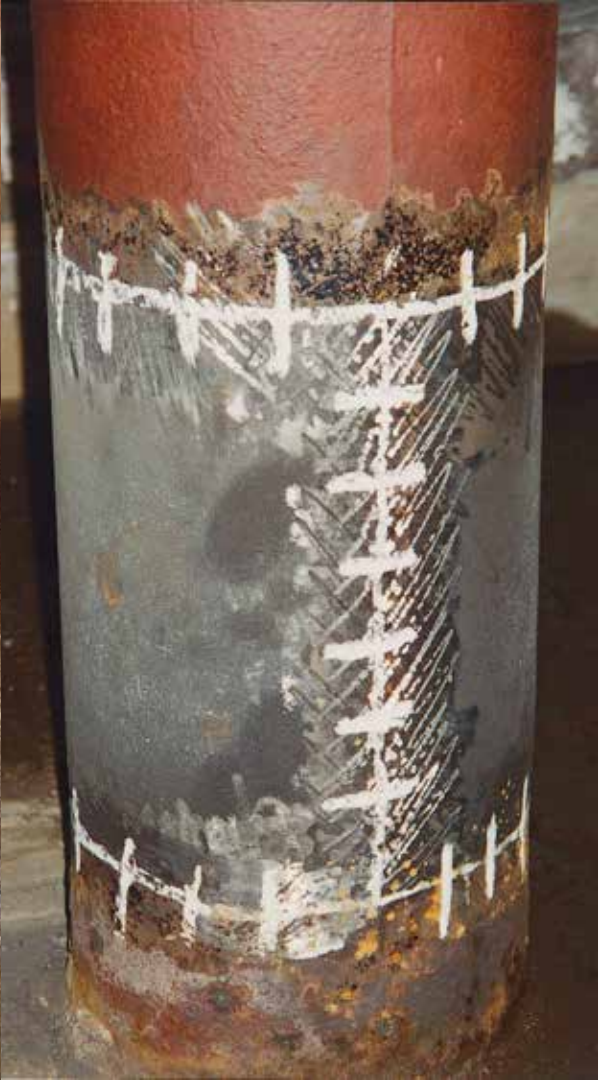
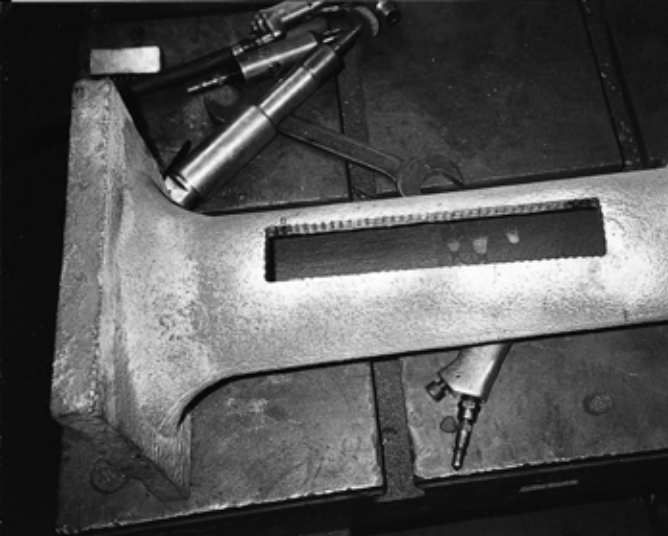
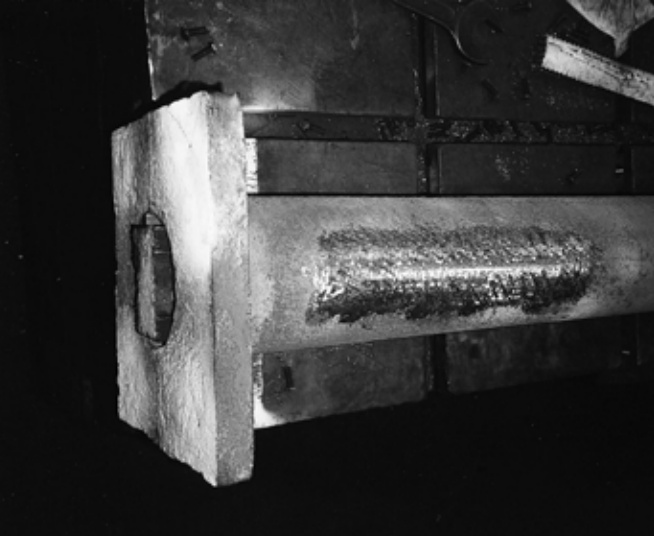
## Support columns

Metalock repairs can be carried out to all sorts of support columns, under workshop conditions or on-site, without the costly need to remove the column. A new section can be cast and split in two halves and cut out of the column to match one of the halves.

The new section can be inserted and secured by the Metalock process, the remaining section can then be removed and replaced with the second new section and finally secured into position.

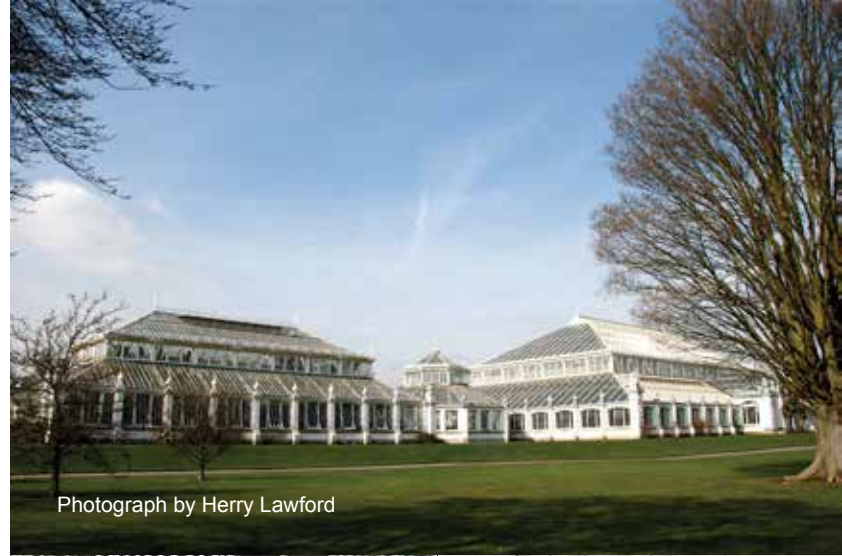
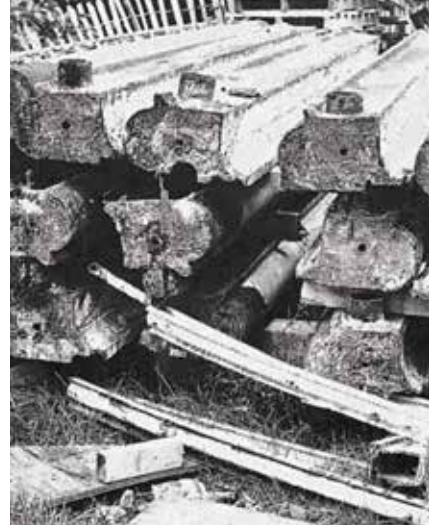
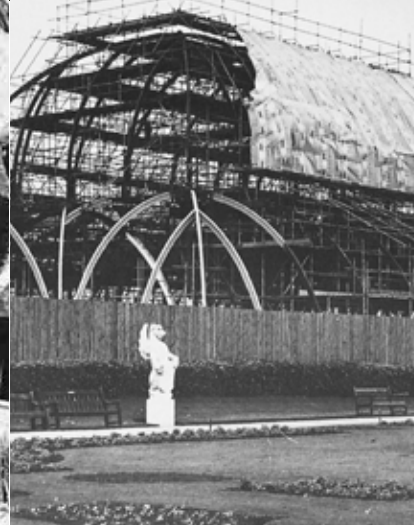
# Kew Gardens

The Palm House forms an integral part of the structure of Kew Gardens, and is being renovated as part of the overall restoration programme. The sills, guttering and floor plates, which are over 100 years old, need to be restored to their original condition.

Metalock are undertaking this work by their cold repair process which restores the inherent strength and is the only way of retaining the authentic appearance of this historic structure.
