Heritage Repairs using the  
Cold Metallock Process

ID7466 Earn Viaduct Perth

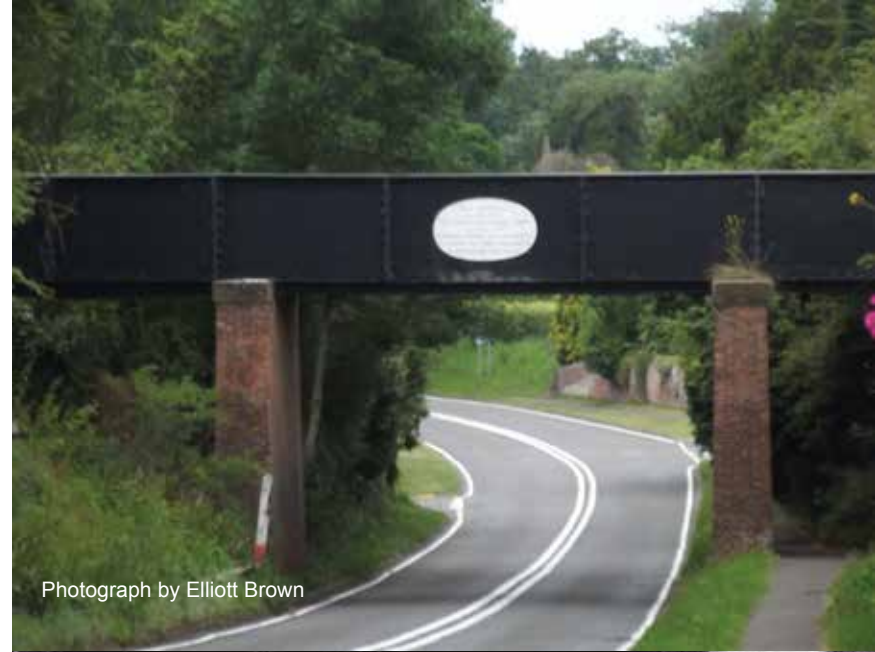
Photograph by Elliott Brown

Built 166 years ago, the Aqueduct at Wootton Wawen was damaged by a heavy road vehicle, causing a 3ft fracture in a cast iron tray. As it carried the busy A34 road from Birmingham time was of the essence.

The watertight repair was successfully completed in four days with minimum disruption to road and canal traffic.

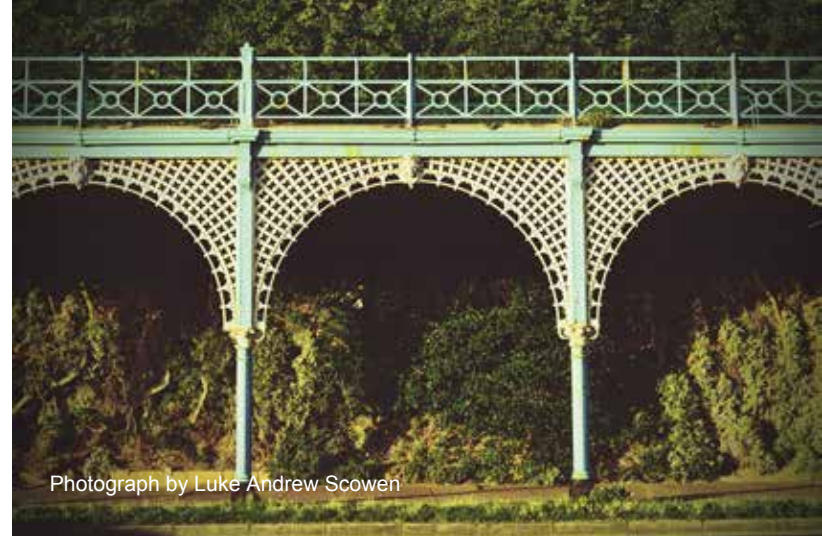
Photograph by Luke Andrew Scowen

The repair, accomplished on site, introduced no additional stresses, which would occur if it was conventionally welded, returning the cracked supporting columns to their original strength.

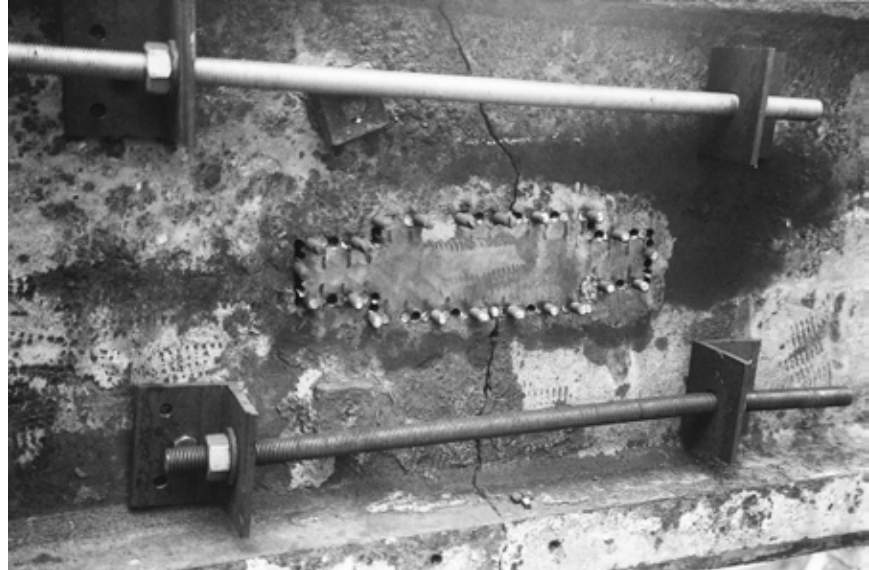
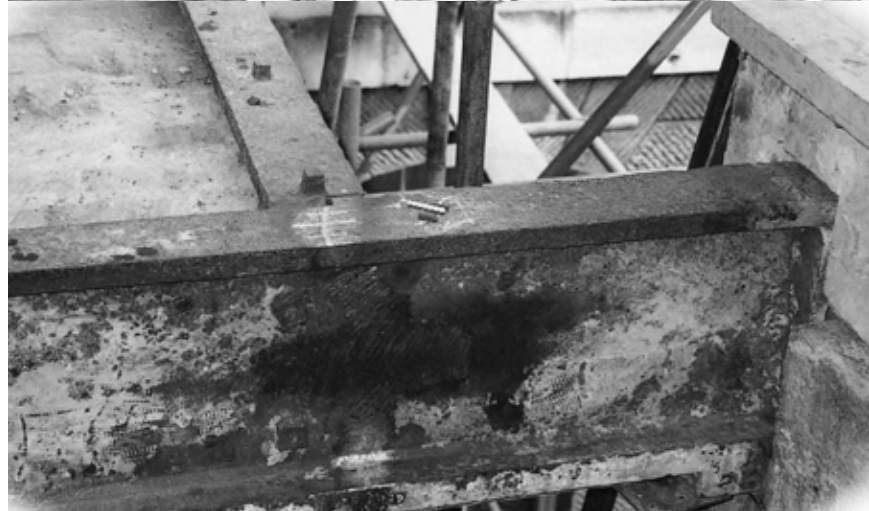
## Somerset House

During refurbishment at Somerset House, inspection to the Main Support Girders showed extensive fractures. These fractures were repaired using a combination of Masterlocks and Metallock Keys, giving additional strength to the repair.
